Project Profile

Residential Deck Project

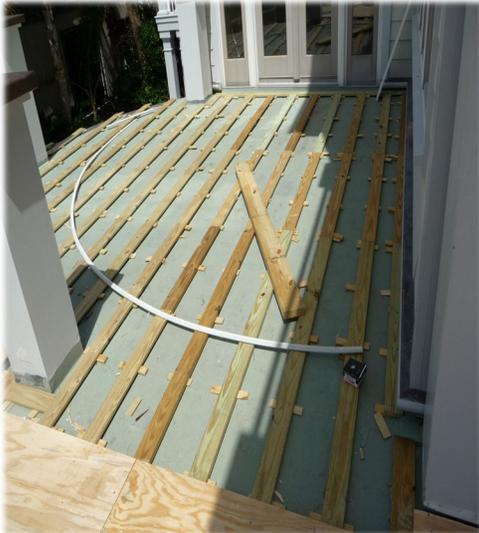
Installing new deck system over old deck

This project was completed by a more experienced crew working with Acrylabs Acrycrete and DEK-coat. The damaged deck was recovered with lath board and 3/4" T & G plywood. Seams were stripped with 4" fabric then the Base System was installed.

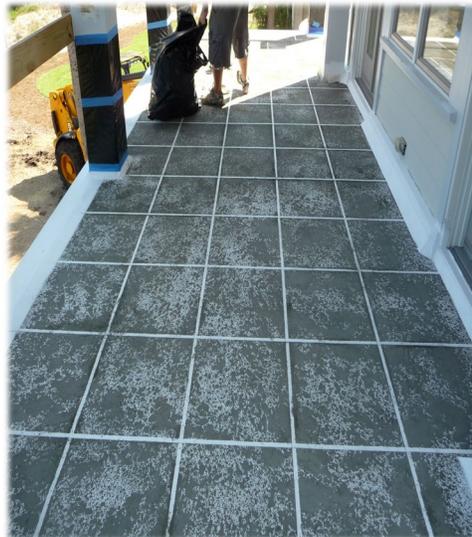
Acrycrete splatter technique knocked down with bull float

After the Acrylabs Base System was installed, painter tape was used to stimulate grout lines, Acrycrete slurry was applied with splatter technique, and painter tape was removed creating clean grout lines

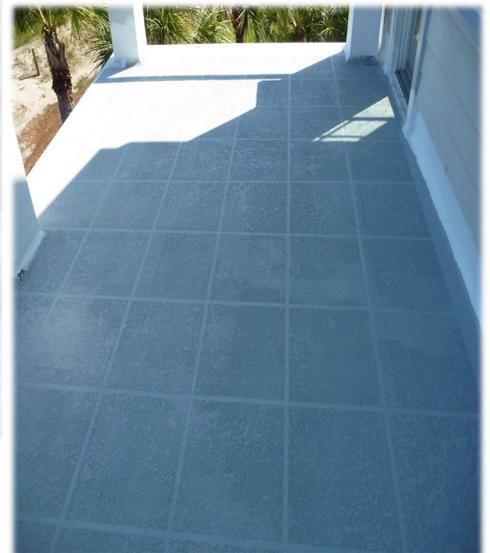
Two coats of Acrylabs DEK-coat finish applied
