Project Profile

Columbia Airport Lagoons

- Columbia Airport Columbia, SC
- Compacted sand bottom and masonry walls
- 3,000-3,500 SF

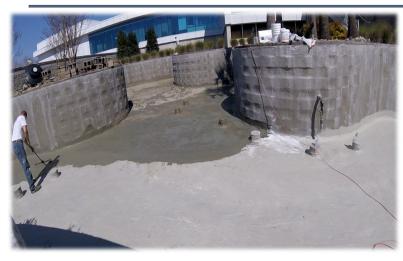
Applying Acrylabs Acrycrete cementitious coating

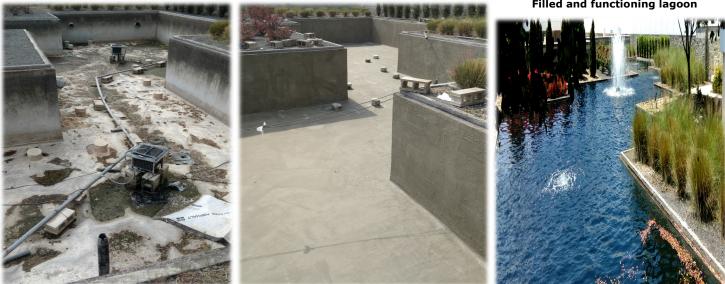
Drained lagoon exposing failures

Completed Acrylabs Base System with Acrycrete applied to floor and walls

Filled and functioning lagoon

These lagoons were designed to hold water for the airport fire suppression. In recent years, they have developed leaks and were loosing large quantities of water. Acrylabs Base Coat and Fabric was applied to the failing surfaces and then Acrycrete was applied to create a watertight and seamless membrane. The lagoons are now leak-free and save the airport hundreds of thousandths of dollars in constantly replacing water.
